# A DATA-DRIVEN CONDITION ASSESSMENT

## FOR ASPHALT REJUVENATION USING MALTENE REPLACEMENT TECHNOLOGY

SEPTEMBER 2021 PREPARED BY JAMES GOLDEN

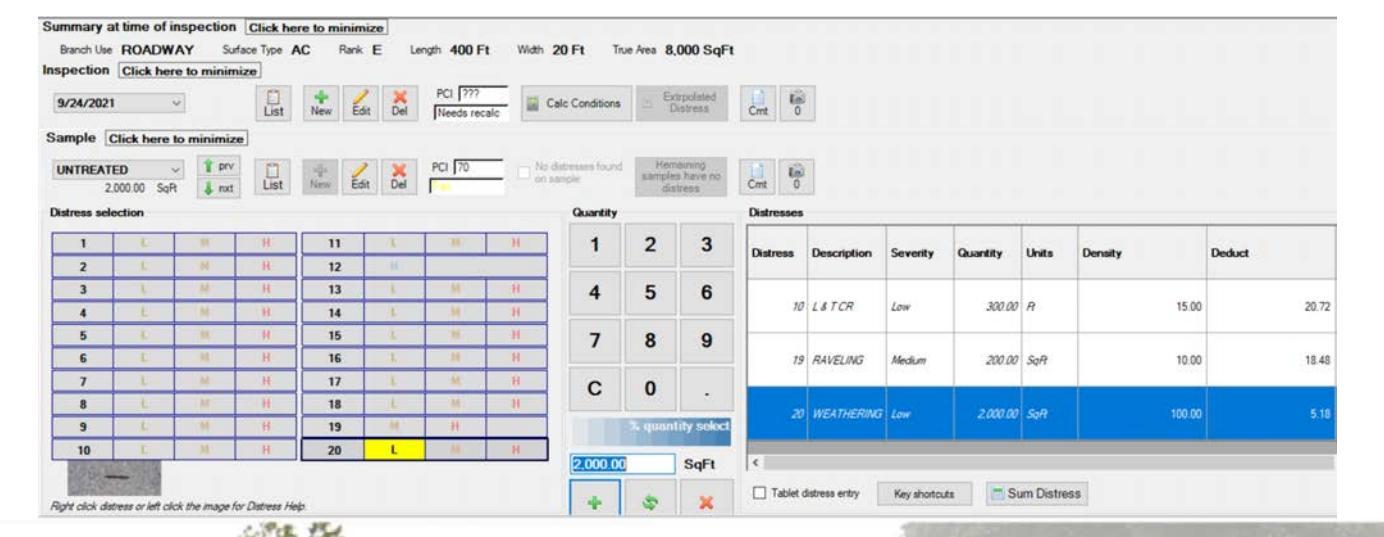
## ASSESSMENT RESULTS STREAMSIDE DRIVE, UNTREATED

# The untreated lane shows noticeable longitudinal and transverse cracking that has been treated with a crack seal since being paved in 2013. Furthermore, you can see signs of raveling throughout 10% of the surface, and weathering throughout 100% of the surface.

After documenting these distresses within the PAVER® pavement management system, the PCI of the untreated lane is a 70.

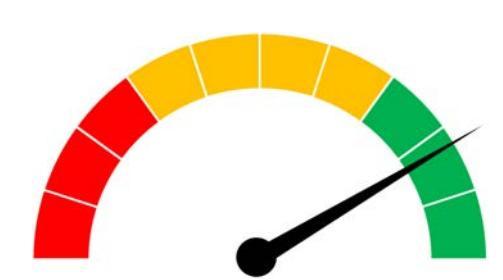
**84 PCI**

## STREAMSIDE DRIVE, TREATED

The treated lane shows that while longitudinal and transverse cracking is visible, it has just started to form and take shape. Furthermore, there are no signs of raveling within the treated surface, with light severity weathering only present within 20% of the surface.

After documenting these distresses within the PAVER® pavement management system, the PCI of the treated lane is 84.

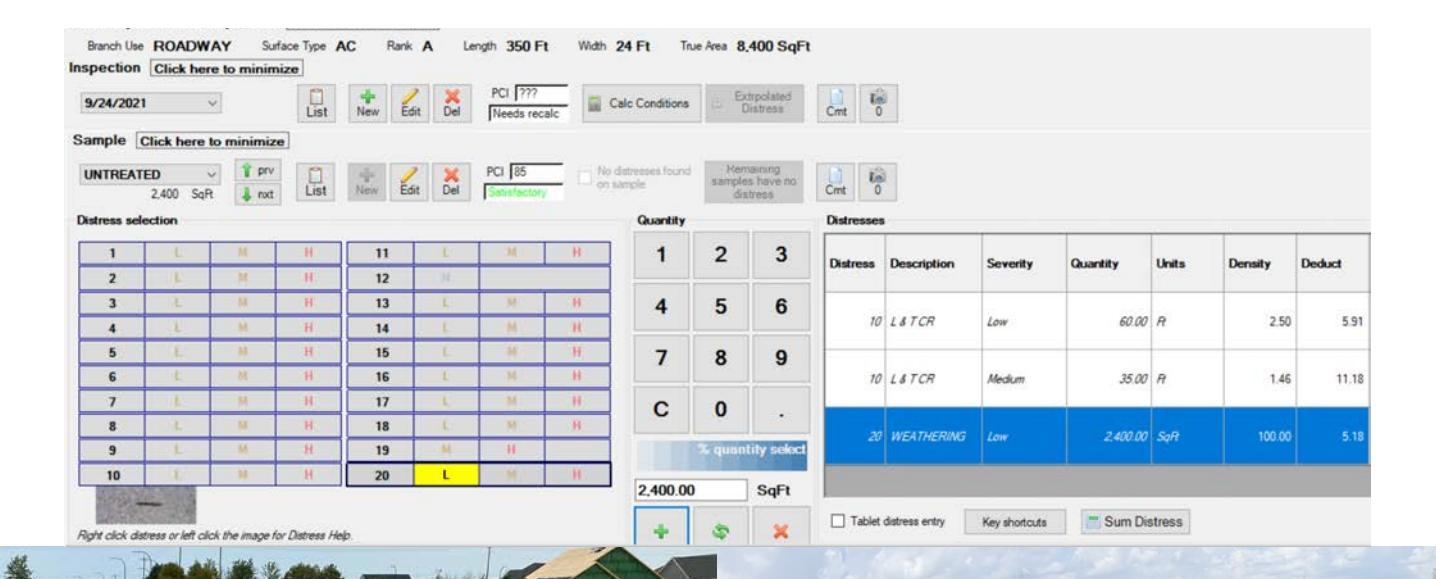
**85 PCI**

## ASSESSMENT RESULTS SAWMILL PARKWAY, UNTREATED

The untreated segment shows noticeable light and medium severity longitudinal cracking along the paving joint with light severity weathering present throughout 100% of the surface.

After documenting these distresses within the PAVER® pavement management system, the PCI of the untreated segment is 85.

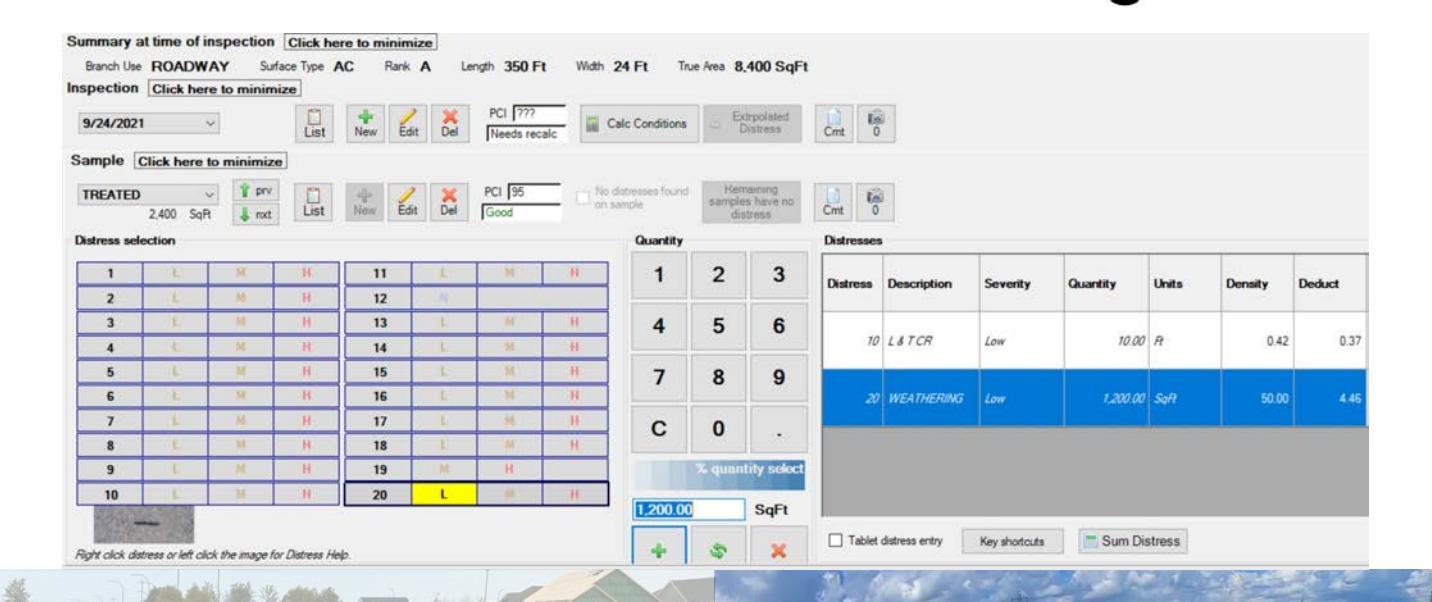
**95 PCI**

#### SAWMILL PARKWAY, TREATED

The treated segment shows minimal, light severity longitudinal cracking along the paving joint, with light severity weathering present throughout just 50% of the surface.

After documenting these distresses within the PAVER® pavement management system, the PCI of the treated segment is 95.

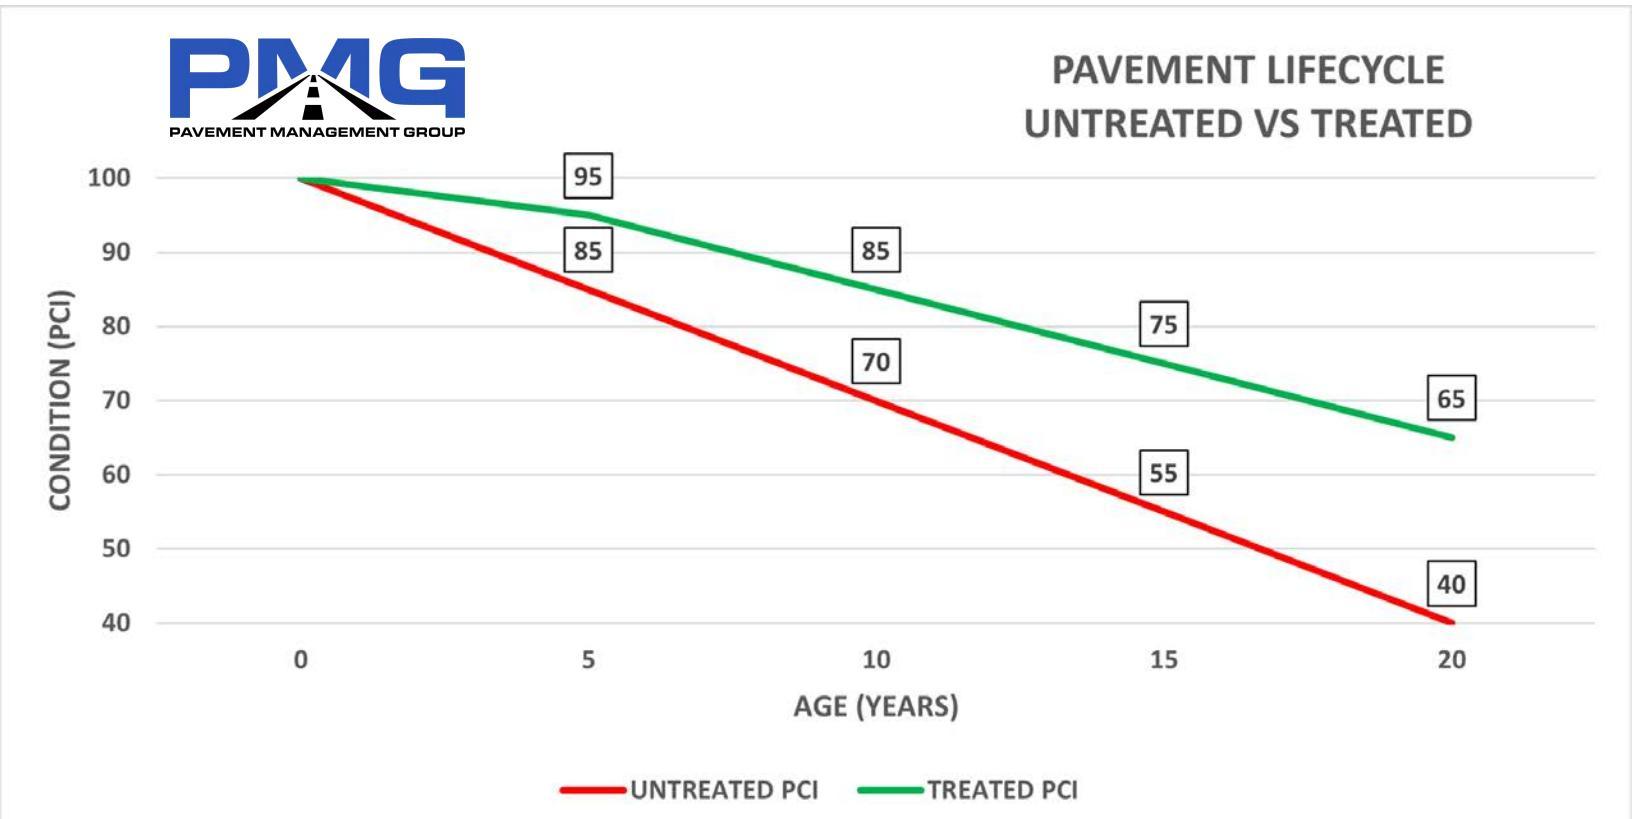
Based upon the age of each pavement and PCI calculated from the ASTM D6433 condition assessment, the untreated locations lost an average of 3.5 PCI points per year, while the treated locations lost an average of just 1.5 points per year; resulting in a 2 point PCI gain.

It is within my professional opinion that an MRT application within the first three (3) years of an asphalt pavement's life will extend the life by up to an additional five (5) years, as shown in the below performance curves created directly from the aggregated data documented within this report.
